# Manhole Inspection Summary

Manhole # S05WW1003MH

**Location** Address: **5816 HIGH GATE DR**

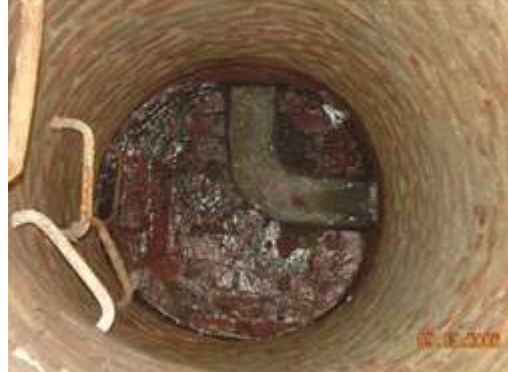
Top View

Adjustment, Corbel, and Barrel infiltration. Corroded steps. Evidence of surcharge - Bench debris.

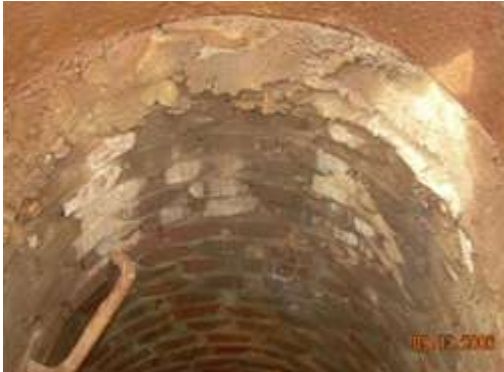
Defect

Frame leaks. Corbel deterioration and loose brick. Adjustment and Corbel infiltration. Corroded steps.

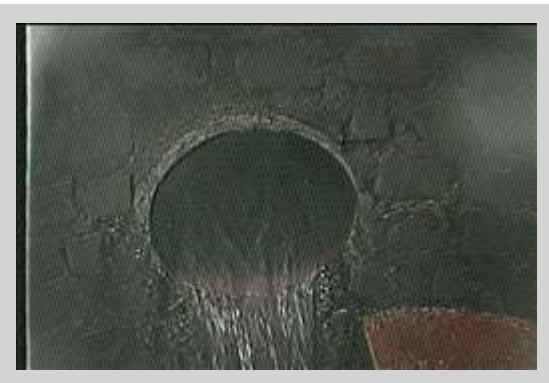
### 10 in. Circular Gravity Sewer Pipe In @ 3 O'Clock

Barrel deterioration and infiltration.

Infiltration: **Evidence** Pipe Seal Cond: **Cracked**
